Current Status of Environmental Conditions Scott Property/Handcraft Tile, Inc. 1696 South Main Street Milpitas, California

MILPITAS MULTI - FAMILY & SENIOR APARTMENTS CITY OF MILPITAS, CALIFORNIA

MILPITAS SENIOR APARTMENTS CITY OF MILPITAS, CALIFORNIA

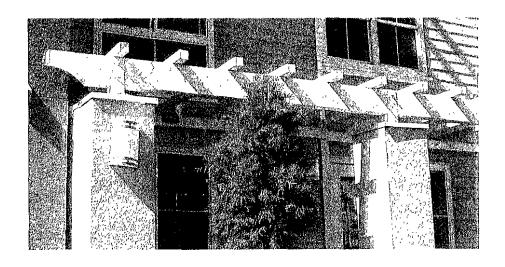
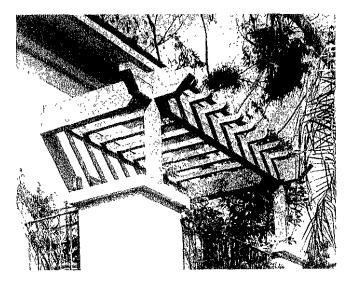
The above photos are of others existing buildings to illustrate the design intent for the proposed trellis at Milpitas Senior Housing. The proposed trellis will be white.

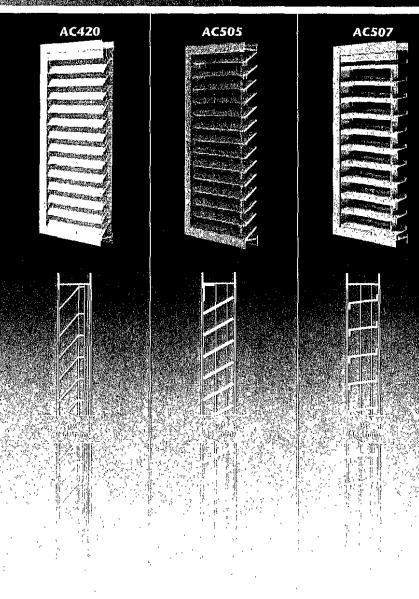
## **Extruded Aluminum** Narrow Profile Louvers

Narrow profile air conditioning grilles provide ultra-high free area for applications where maximum intake or exhaust air is required and weather protection is not a principal concern. Light in weight, each design can be supplied with a hinge arrangement for use as sun or vision screens. All are available with standard visible mullions and continuous blade design.

Recommended Specification:
Furnish and install Narrow Profile Lower Type AC507 as designed and manufactured by The AIROLITE Company, Marietta, Ohio USA, Louvers shall be constructed entirely of extruded aluminum, alloy 6063-T5. Blades shall be minimum 0.081" (2.06mm) wall thickness. Frames shall be minimum 0.063" (3.60mm) wall thickness. Louver assemblies shall be 1½" (38.1mm) deep with 7 degree stationary blades, Each louver shall be fitted with ½" (12.7mm) mesh x 0.063" (3.60mm) diameter aluminum bird screen in non-rewirable U-shaped frames for permanently securing screen mesh.
